## **Ellan Vhow, Loch Lomond**

### **Preliminary Report on Site Work during October 2013**

**By Fiona Baker**  
**Firat Archaeological Services Ltd for the**  
**Ellan Vhow Preservation Fund**

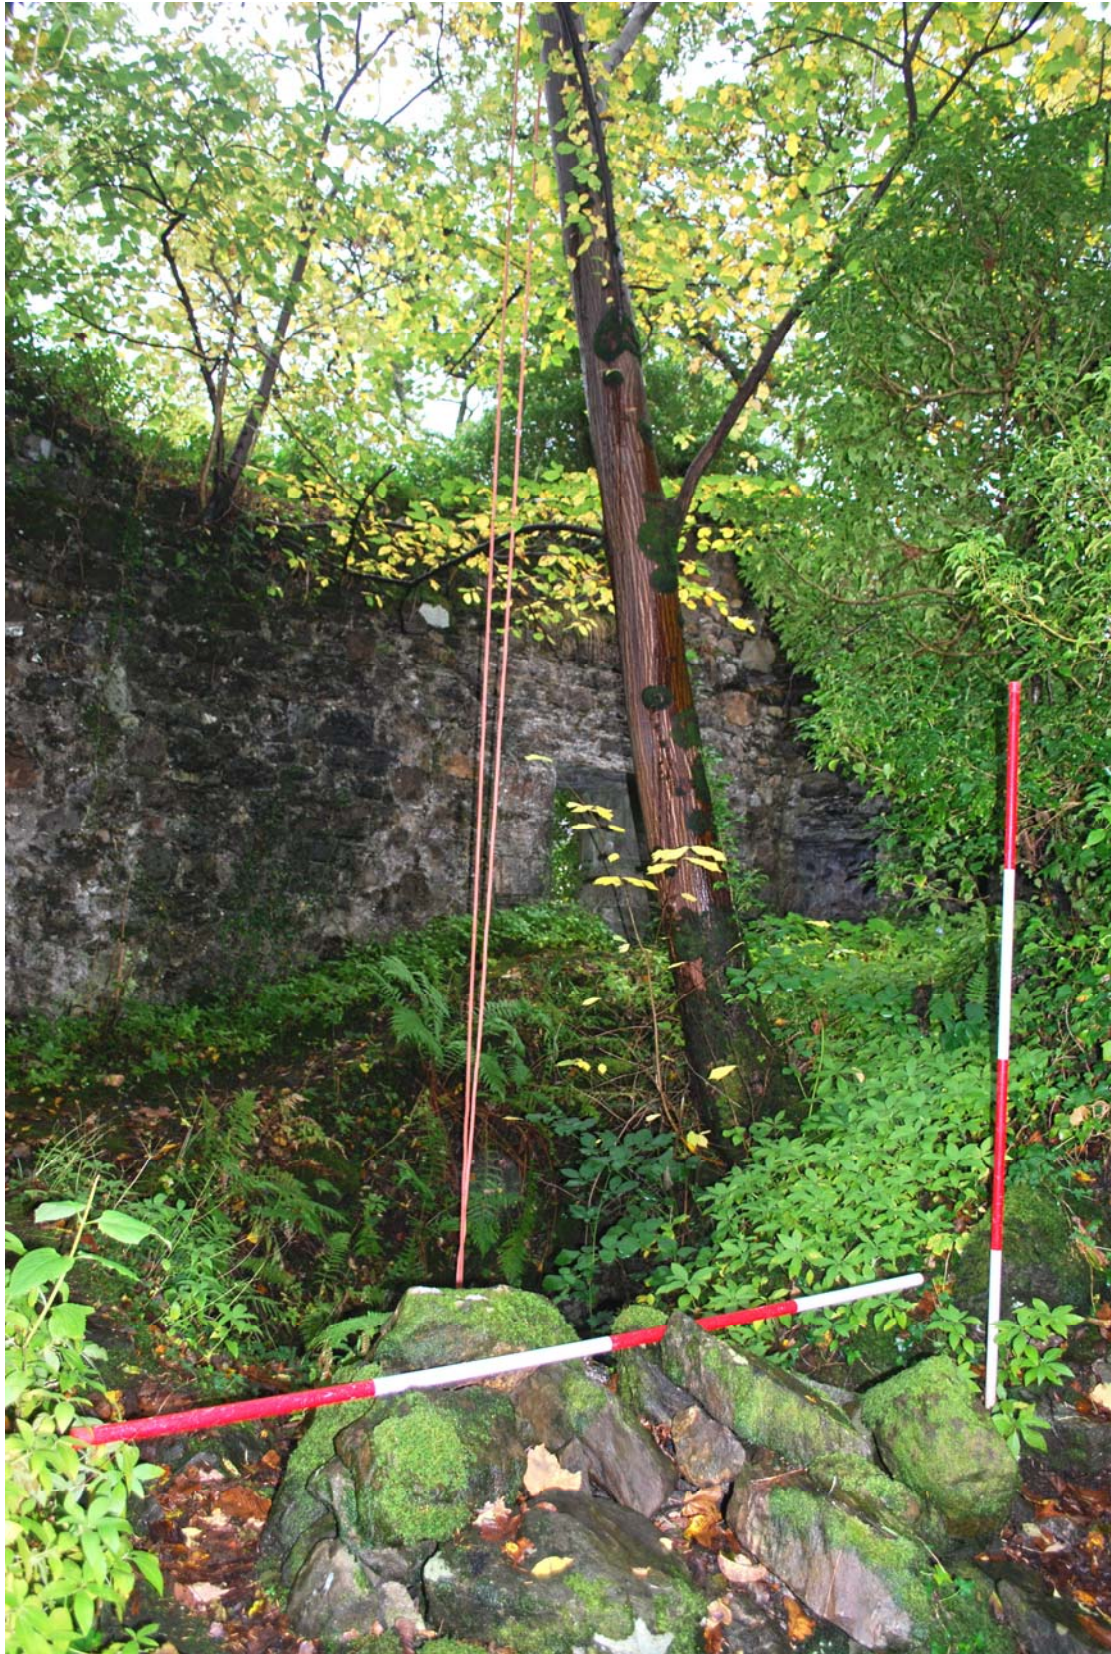
The main tree felling objective was the Scot's Elm tree growing out of the accessible vaulted cellar (W side of the tower, the probable vaulted cellar on the E side is not accessible and its entrance is obscured by collapse). The roots of this tree have penetrated the vault and are causing considerable stress on the roof of the vault. The tree has been felled by chainsaw to a stump approximately 30cm above ground level from which it will regenerate. The root plate has been left intact so the tree remains alive but the new growth can be maintained by coppicing and it is hoped that as the growth has been curtailed the root plate will not increase.

View to SSW of the Scot's Elm growing out of the vault prior to felling.

1. Felling of the elm tree (*Ulmus glabra*) growing out of the vaulted cellar in order to reduce its weight and vigour and so that the tree's energy will go into new growth which can be managed by coppicing and reduce further root penetration into the masonry.
2. Felling of saplings growing in the wall heads and outwards for the walls without disturbing their roots so that growth is curtailed and the weight and stress on the wall heads is reduced.
3. Hard trimming back of the ivy growth on all walls to reduce the weight and stress on the walls and restrict the spread and vigour of the ivy. The main stems were not cut so the ivy will grow back.
4. Standing building recording of all tower elevations by scale drawing and photogrammetry (as per the Phase 2 works described in the March 2013 report).
5. Topographic survey of the whole island.

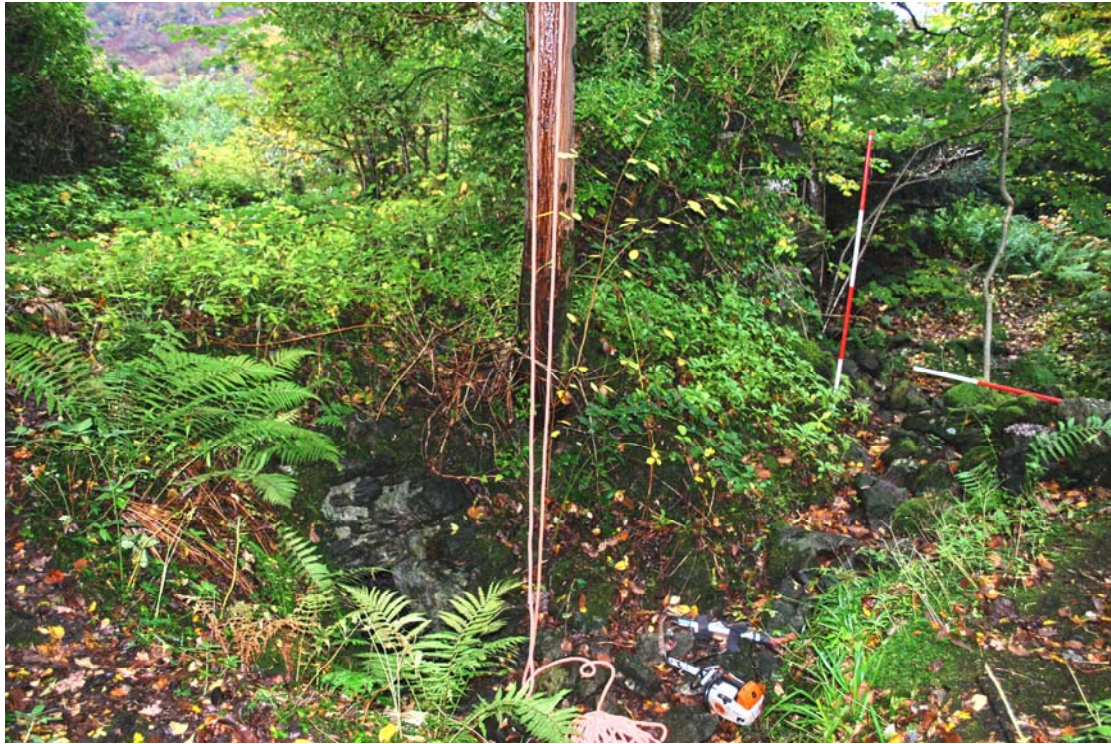
View to WNW of the Scot's Elm growing out of the vault before felling.

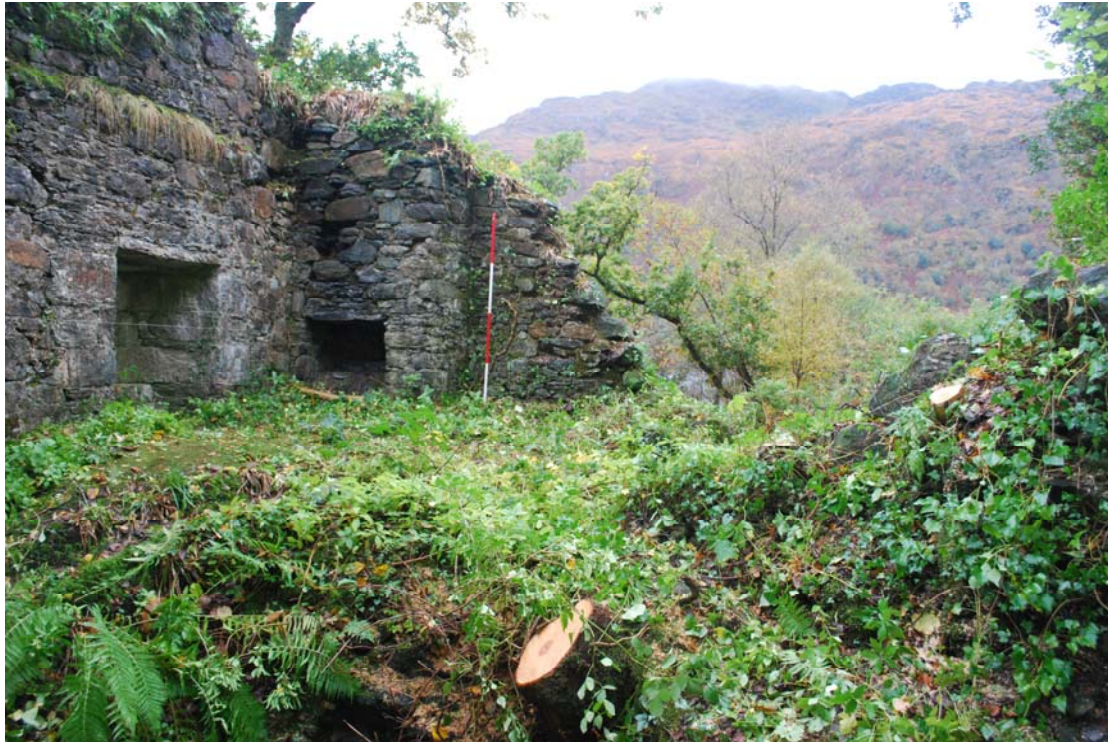
View to the W of the interior of the tower following the felling of the Scot's Elm (tree stump in foreground) and other small trees and saplings.

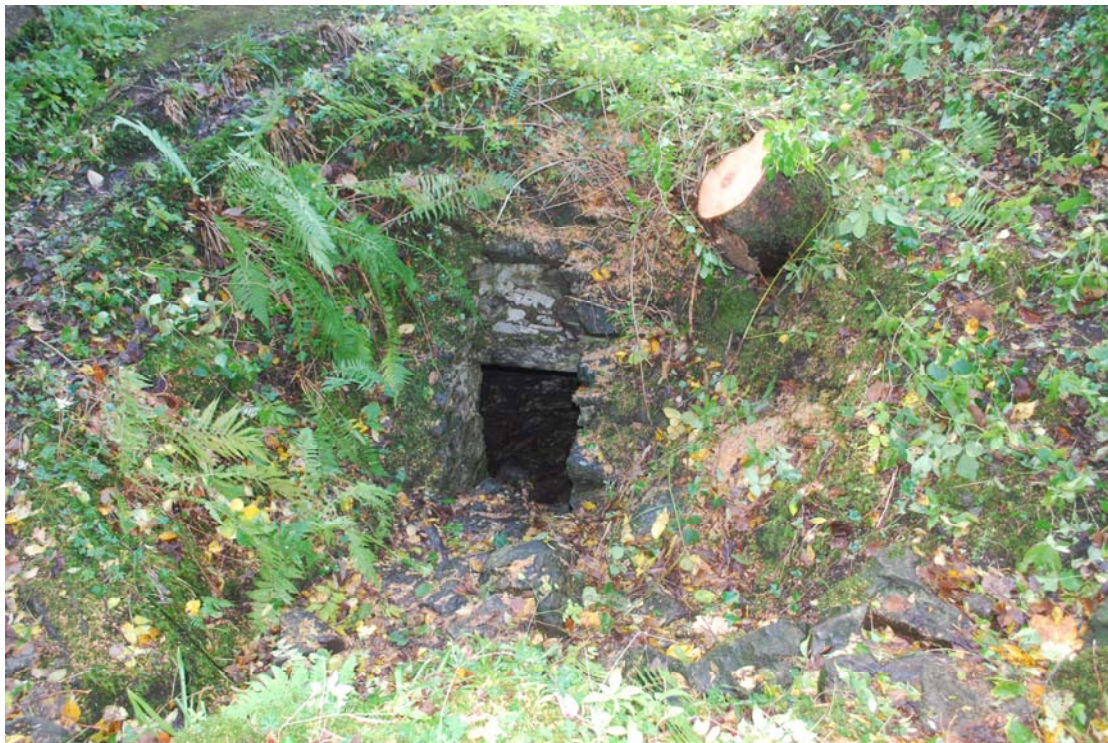
View to W of the entrance to the vault and stump of Scot's Elm after felling.

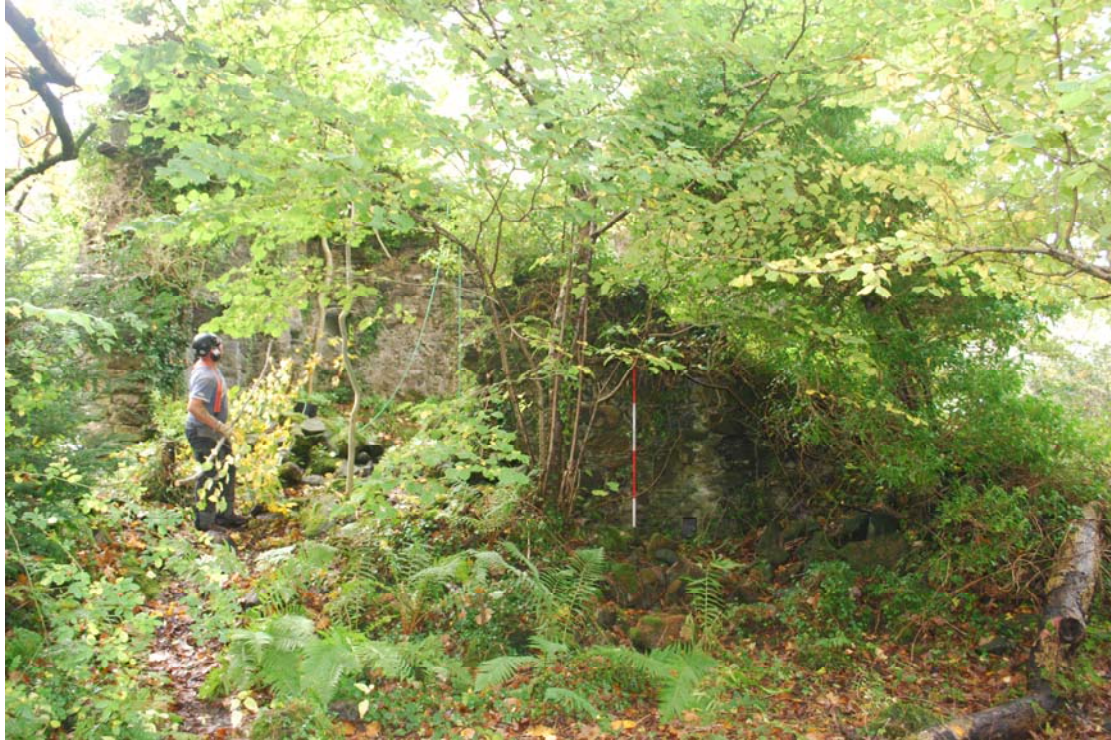
View to the S, North Wall exterior prior to cutting back of saplings and ivy.

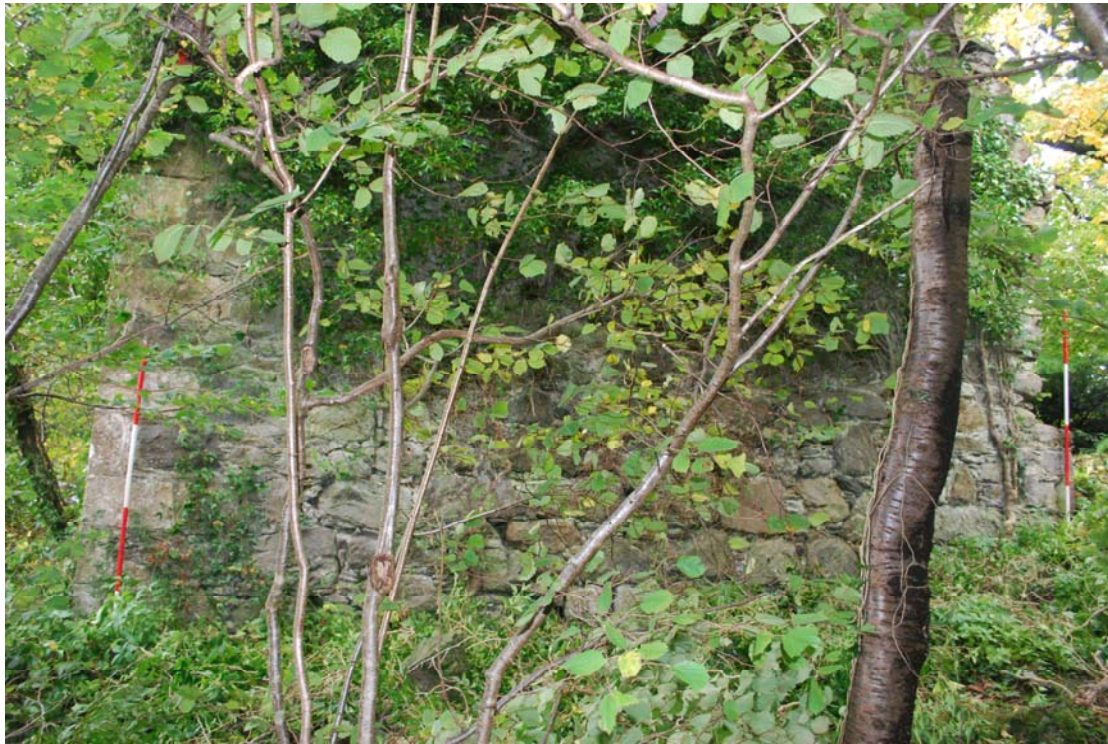
View to W of the exterior of E wall prior to ivy trimming.

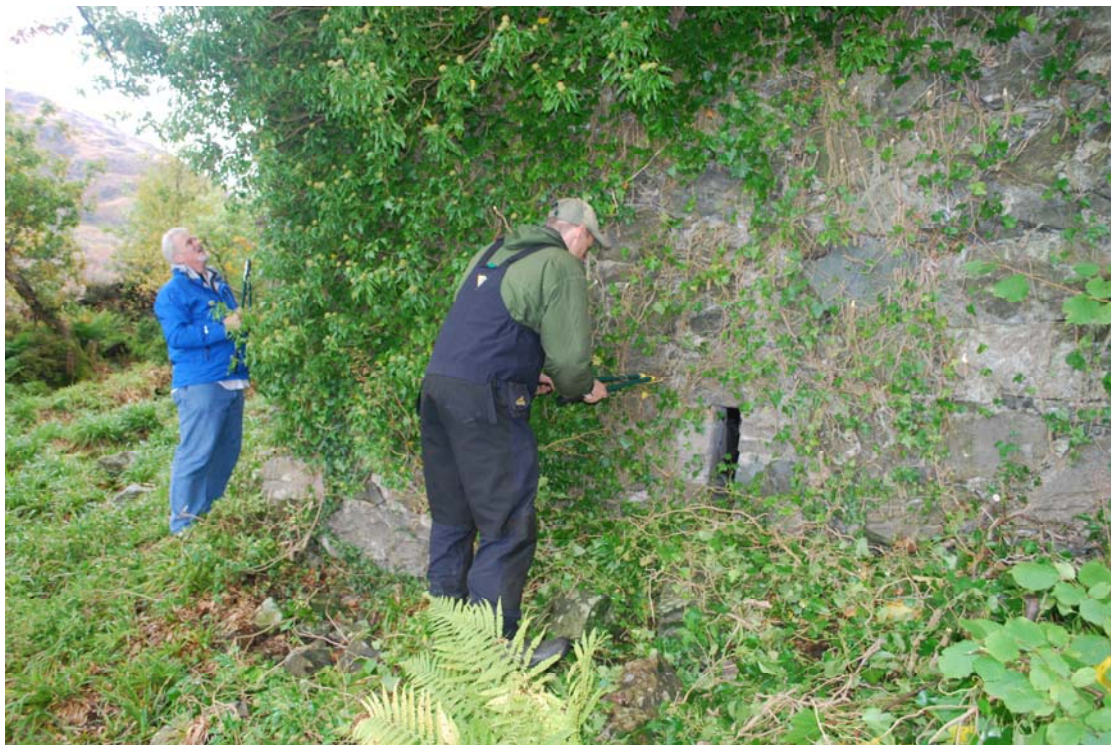
View to W, Bruce McFarlin and Myles Maydew removing ivy from the S wall, ventilation slit to vaulted W cellar exposed.

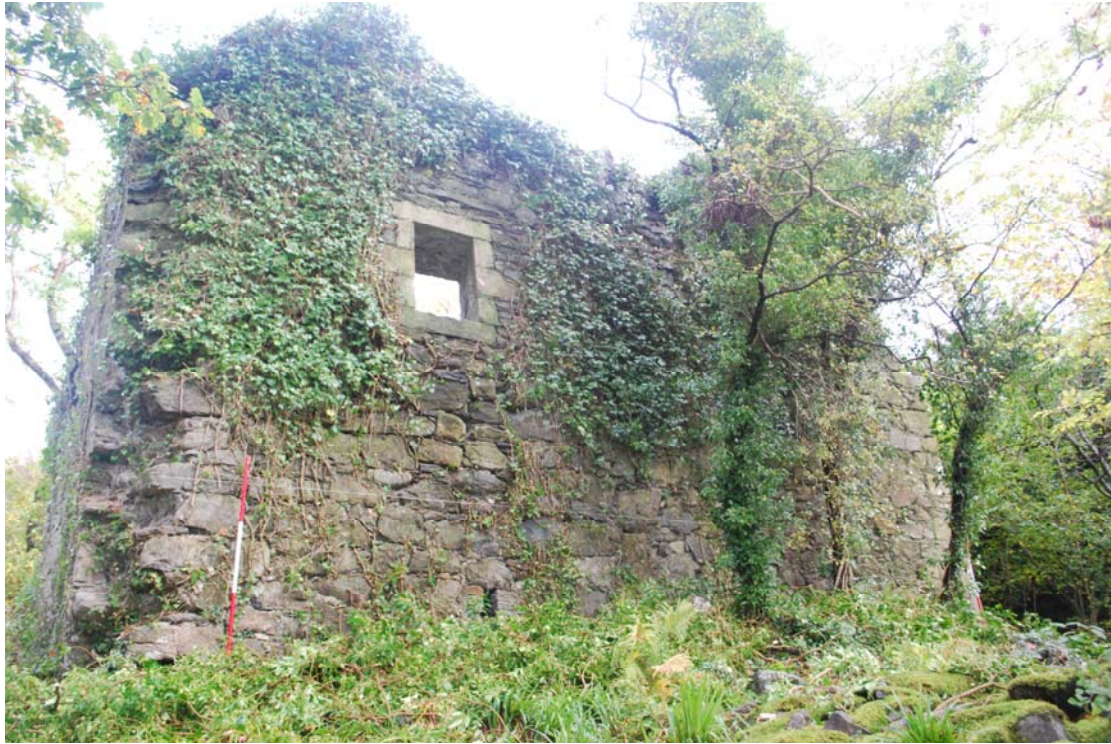
View to N of the exterior of S wall after ivy trimming. The three trees at the right of the photograph are growing out of a heap of collapsed stones and we recommend these trees are also felled to stumps so that their roots do not increase and their energy is put into top growth that can be managed by coppicing.

There are also three trees growing out of collapsed stones located at the E end of the S wall (exterior) that it would be beneficial to fell. These trees (see photograph below) were not specifically identified in the current SMC and as their girth is greater than 10cm (perhaps 20cm – 30cm) they were not felled during the October work as it was felt this would have exceeded the agreed works. The trees are as tall as the tower and it is felt that before their roots extend any further towards / into the tower foundations it would be beneficial to fell them to stumps so that they can be managed by coppicing in the future.

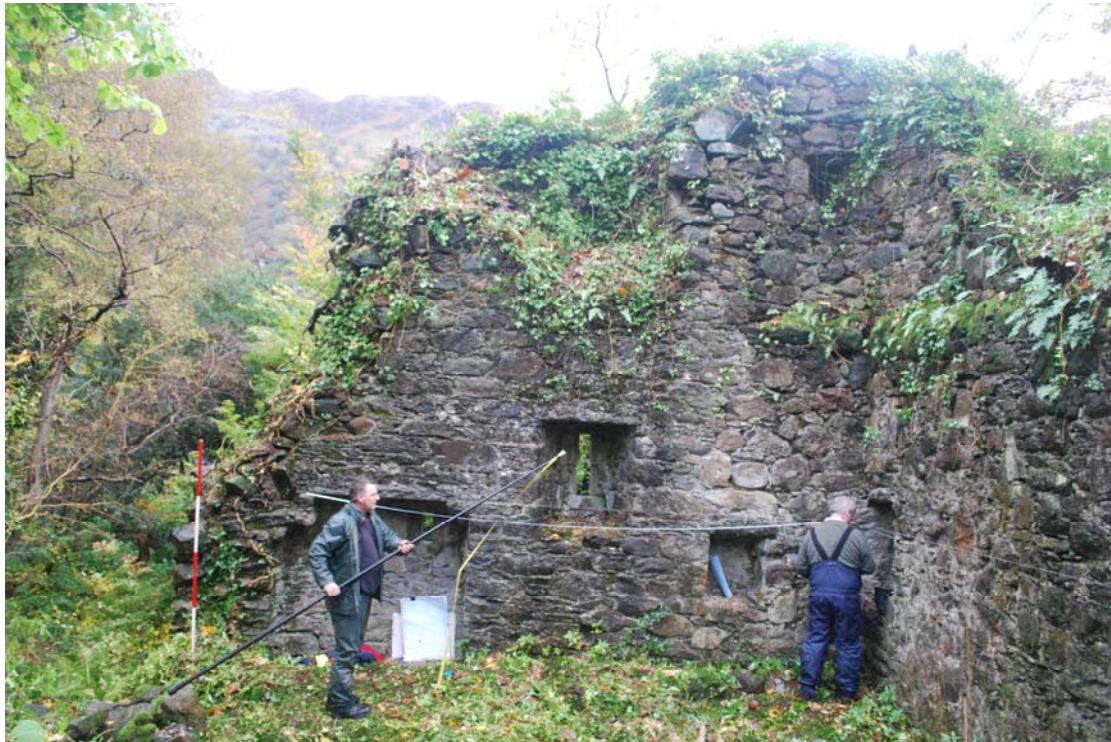
The cutting back of the ivy and use of ladders allowed the walls of the tower to be fully inspected for the first time. Our initial impression is that the walls are in much better condition than might have been expected considering the dense ivy growth. The wall heads are unstable and require consolidation works to ensure they remain intact and apart from cutting the saplings no vegetation was removed from the wall heads as it is reducing water ingress into the wall core and the roots are actually holding the wall together at the wall head. Lime mortar repointing will also be required in places and these proposed consolidation works will be detailed in the forthcoming report on the standing building recording and condition survey.

View to the E, David Connolly and Tom Addyman recording the interior elevation of the E wall after elm, ivy and saplings removed. Note vegetation left on the wallheads to help protect the wall core.

The dense ivy covering the tower's walls was cut hard back with hand tools but the main stems were left intact. The ivy at the top of the walls was only lightly trimmed back to reduce the weight but the wall heads themselves were undisturbed (apart from cutting back saplings). The wall heads are vulnerable and more subject to erosion than the walls and without a programme of consolidation works in place it is considered the best course of action is to leave them undisturbed.
